# 2022 Maidstone Lake & Tributary Water Quality Monitoring Results: Lay Monitoring Program and LaRosa Partnership Program

Mark Mitchell, Lake Monitoring and Community Outreach Coordinator
VT Department of Environmental Conservation, UVM Lake Champlain Sea Grant

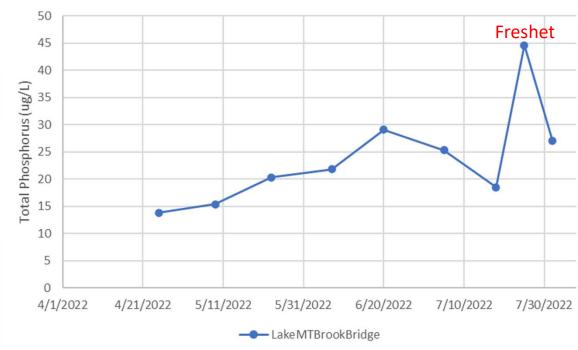
## 2022 Maidstone Lake Tributary Monitoring Total Phosphorus Results

Mean Total Phophorus	(ug/L)	24.0
Minimum Total Phosphorus	(ug/L)	13.8
Maximum Total Phosphorus	(ug/L)	44.6

- Lay Monitoring Program (LMP)
  - 2022 Summary: Hose samples have slightly higher total phosphorus concentrations than surface samples, but both correlate with Secchi and chl-a
  - 2023 Next Steps: LMP volunteer collects biweekly surface while LMP coordinator collects water quality vertical profile during visit; add caffeine testing as human wastewater indicator (i.e. septic systems)
- LaRosa Partnership Program (LPP)
  - 2022 Summary: LakeMTBrookBridge had increasing TP, 3X higher during freshet
  - 2023 Next Steps: LPP volunteer continues collecting biweekly samples through August and investigate tributary upstream for potential problem areas

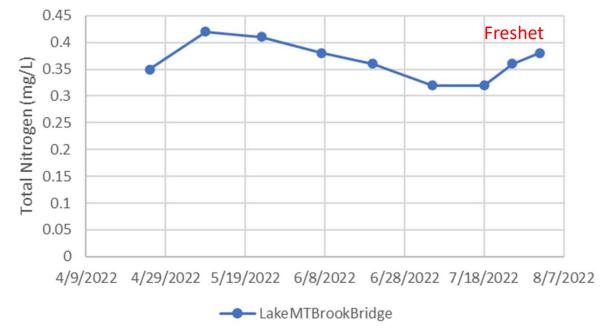
### 2022 Maidstone Lake Tributary Total Nitrogen Monitoring Results

Mean Total Nitrogen	(ug/L)	0.37
Minimum Total Nitrogen	(ug/L)	0.32
Maximum Total Nitrogen	(ug/L)	0.42
